Design Guidelines: Masonry

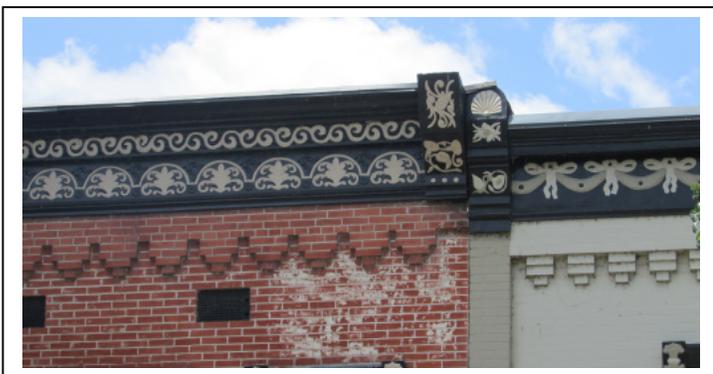
This brick corbelling is an important architectural detail on these North Capitol Avenue commercial buildings and should be preserved.

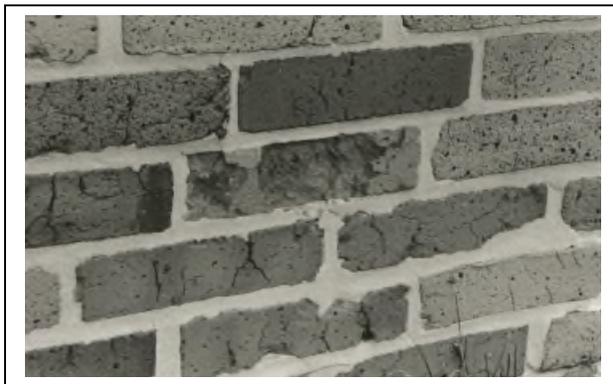
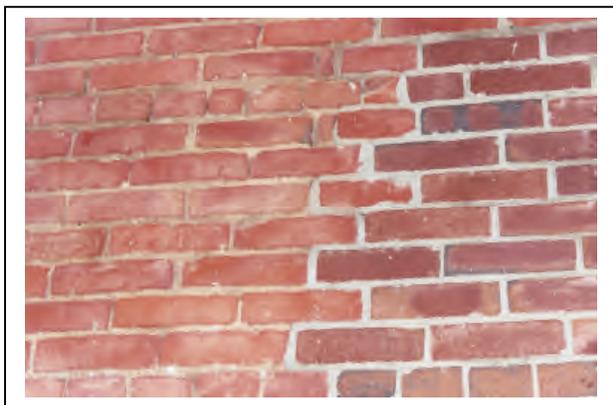
Sandblasting has damaged these bricks (top), pitting their surface and removing the hard, outer fireskin. At bottom, the Portland cement-based mortar used to repoint does not match the historic mortar to the left, and will eventually lead to the deterioration of the brick.

M11 Sandblasting and other abrasive cleaning methods are prohibited.

M19 Use a mortar mix that is compatible with the historic masonry. Historic mortars were high in lime content and much softer than today’s Portland cement-based mortars. Repointing mortar should be equivalent to or softer than the original mortar.

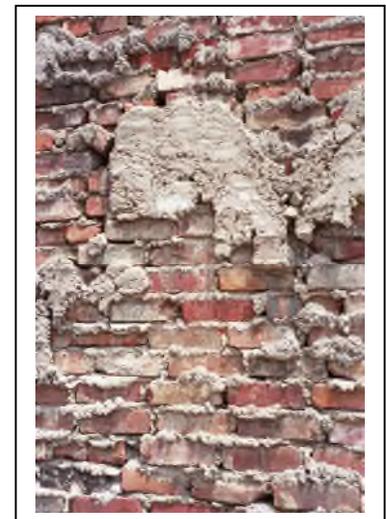
These soft bricks were meant for interior use and will deteriorate rapidly once exposed to the elements.

M3 Make sure that any exterior replacement bricks are suitable for exterior use – some bricks were never meant to be exposed to the elements.
